Manhole Inspection Summary

Manhole # S35II_005MH

Insp Date: **3/14/07 9:04 AM**

Location Address: **1602 LATROBE ST**

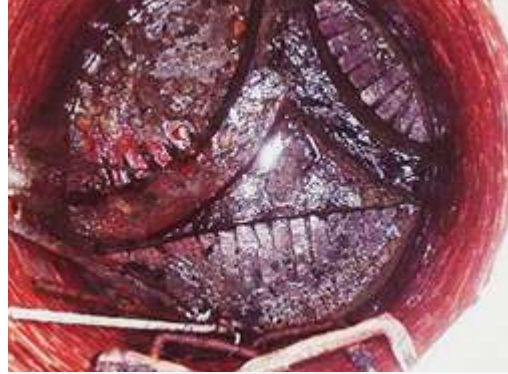
Top View

Corroded steps. Evidence of surcharge - Bench debris. Channel debris.

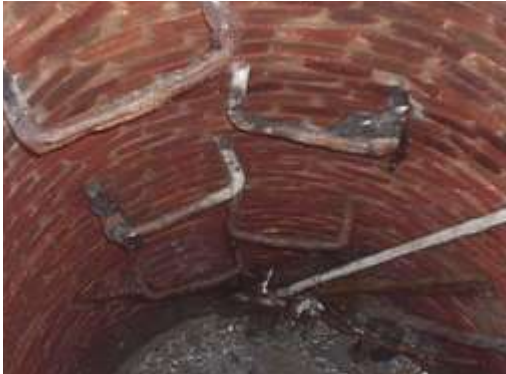
Defect

Corroded steps. Evidence of surcharge - Bench debris.

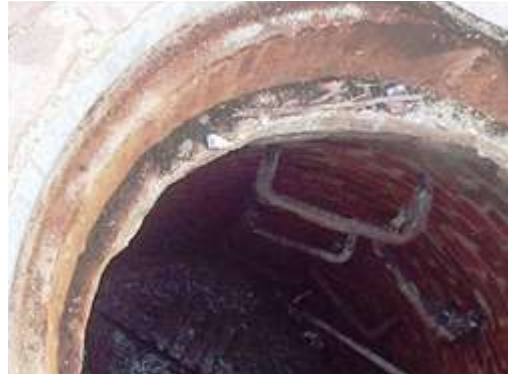
Defect

Frame leaks. Frame offset. Adjustment deterioration and infiltration.

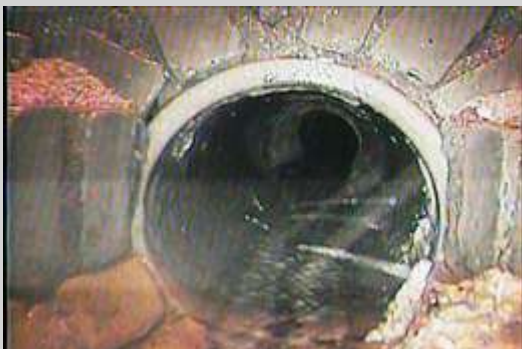
8 in. Circular Gravity Sewer Pipe In @ 3 O'Clock

Deposits: ☐ None ☐ Mud ☐ Sludge ☐ Debris ☒ Grease

Silt Depth: **0** (in.) Deposits Extent: **Light**

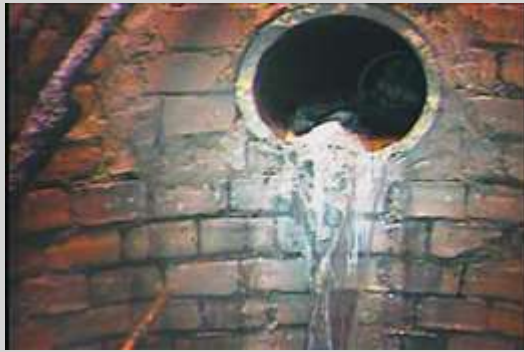
Pipe In @ 9 O'Clock

Barrel deterioration and infiltration.

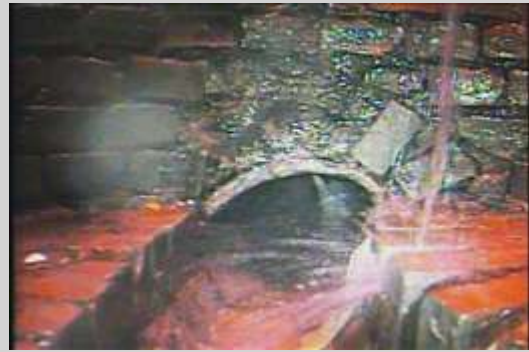
Drop In @ 9 O'Clock

Barrel deterioration and infiltration.

Drop Condition: **Partly Clogged**
